MIDDLE CREEK DAM (HYALITE)

Fact Sheet

DEADMAN'S BASIN DAM

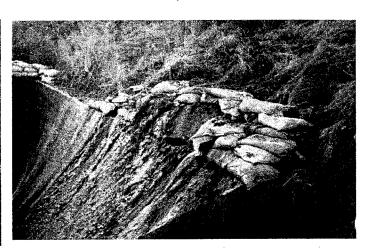
Low Level Outlet
